INSPECTOR IAN

Home Inspection Report #2012xxxx

Date of Inspection: April 7, 2012

For the Property located at:
Sample Report

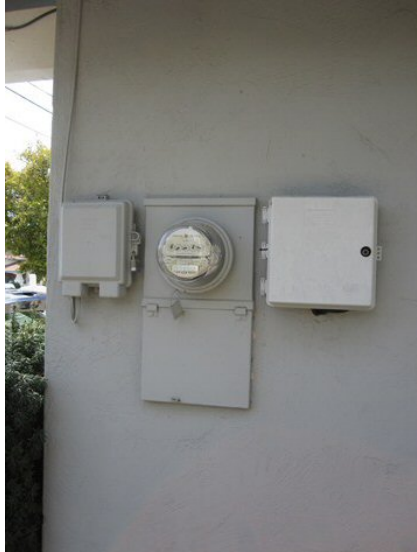
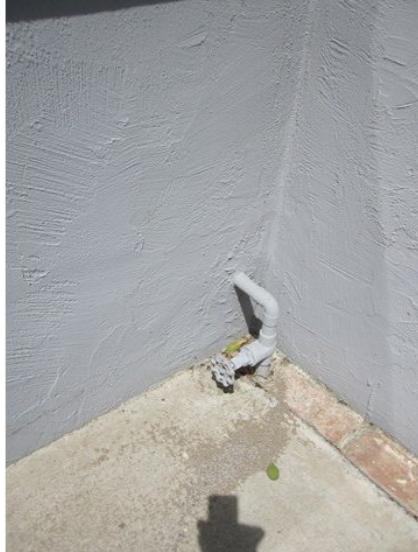
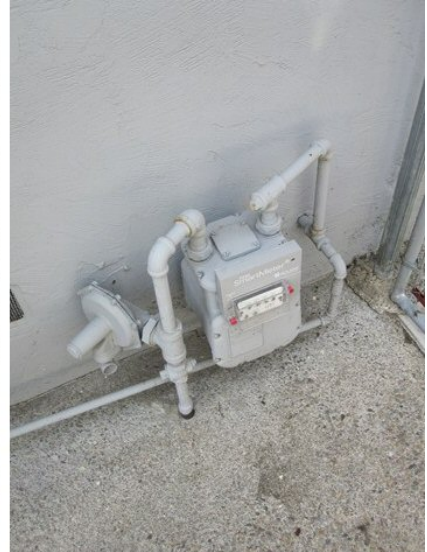
Electric Meter/Service Panel: Right side at front (below left)
Water Shut-Off: Left side of garage (below center)
Gas Meter: Right side at front (below right)

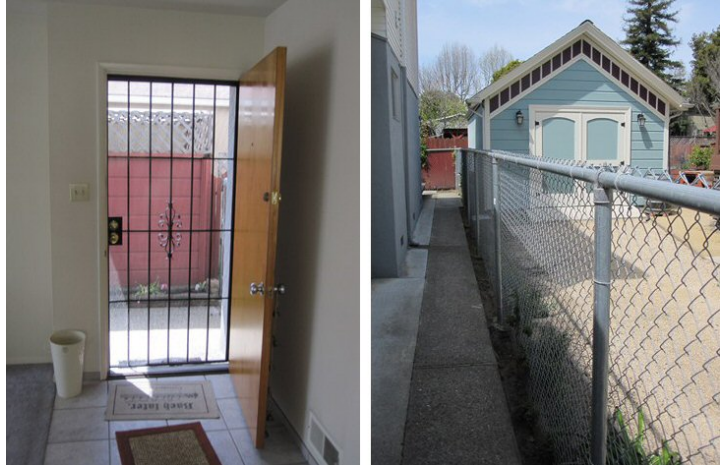
Comments: The overall condition of the entranceway was noted to be serviceable.

Recommendations: None.

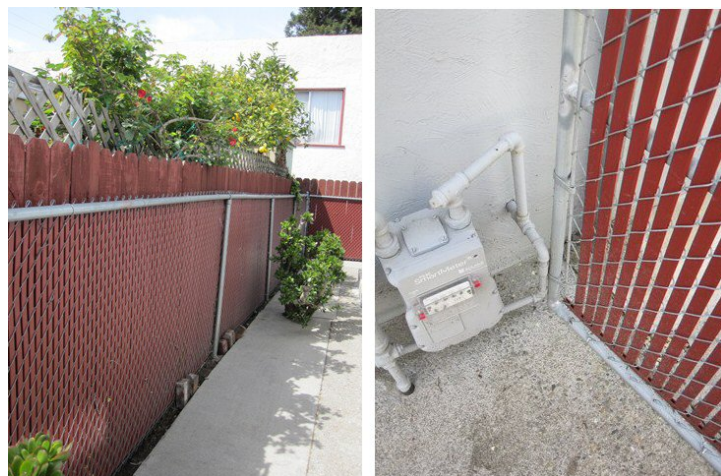
Comments: The sides and rear of the lot are enclosed by chain link fences with secure gates present at both sides of the building. Gates and fences were found to be in serviceable condition. The right side gate does not clear the gas installation, and must be opened inwards. Repeated miss-use may damage the gas piping.

Recommendations: Reverse the swing of the right side gate to clear gas meter pipe work.

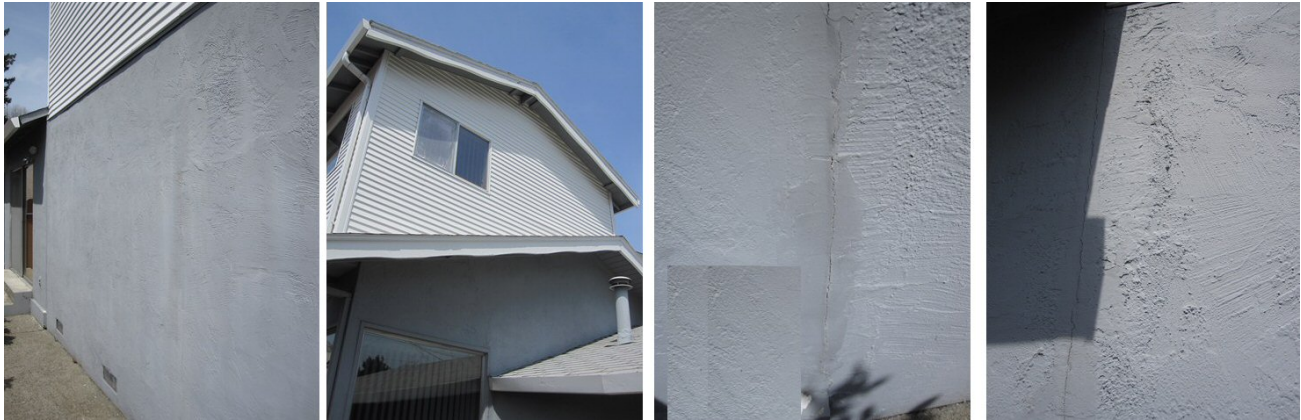
Comments: The walls were found to be in generally adequate to serviceable condition. There were some minor stress cracks in the stucco at the rear of the left side.

Recommendations: fill cracks in the stucco to prevent water penetration.

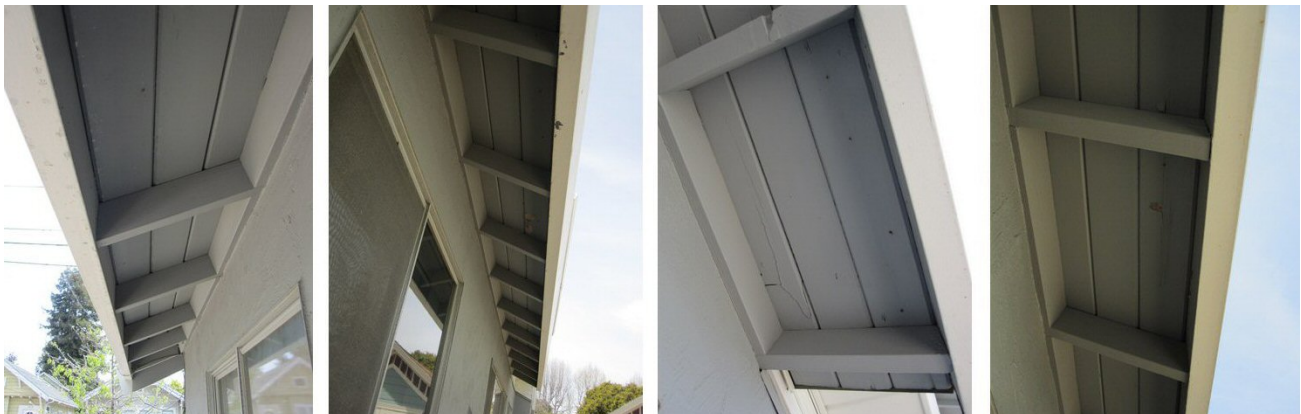
Trim

Comments: The trim consists of eaves, fascia, and window and door trim. The overall condition of the trim was noted to be adequate with several areas of peeling paint. There was some damage to the wood at the side of the garage door..

Recommendations: repaint the trim below the overhang. All loose paint should be removed before repainting and any rotten or damaged wood replaced.

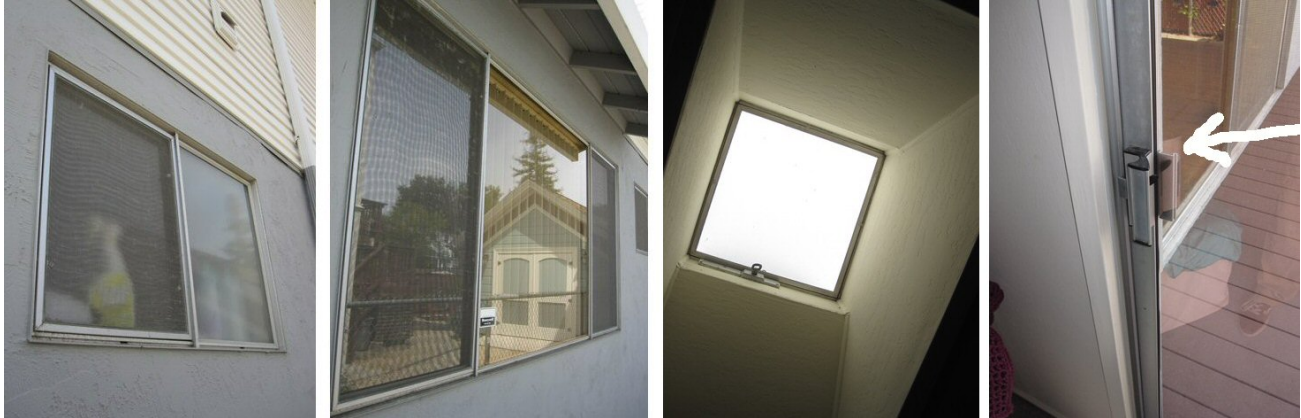
Comments: Windows are aluminum-framed units with horizontal and sliding panes and some fixed panels. The overall condition of the windows was noted to be adequate. Several windows were stiff and/or difficult to operate. Most windows were fitted with screens which were found to be in adequate to poor condition with small tears and/or holes. Several screens were missing. Four skylights are present above the upper level. There was evidence of minor moisture penetration at one skylight. There was some damage to the ceiling in the same area (see living areas section, below). The rear slider in the right side bedroom was very difficult to secure in the closed position.

Recommendations: relocate the position of the slider door handle/latch. Torn, damaged or missing screens should be repaired or replaced.

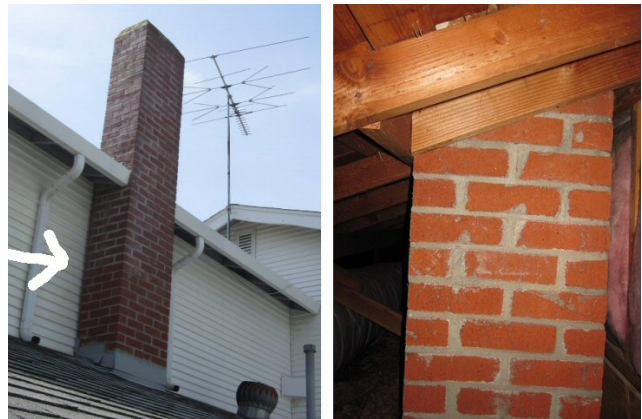
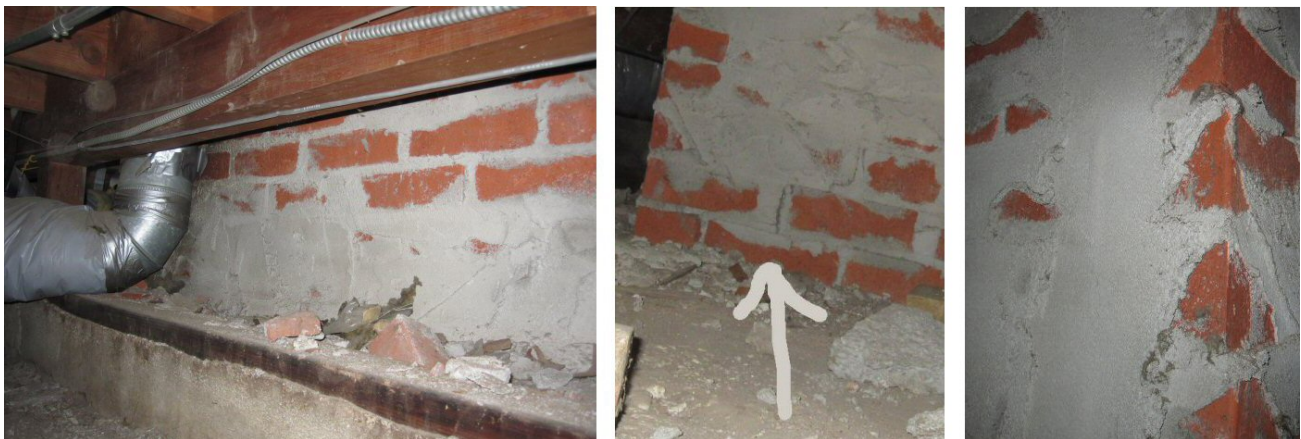
Chimney

Comments: The visible areas of the exterior of the chimney were inspected from the crawls space, attic and from the exterior of the building. The chimney has been modified since the original construction. Texture of the bricks at the exterior is not consistent throughout the entire length. The base of the chimney has been fortified with mortar (arrow).

Recommendations: monitor the condition of the chimney.

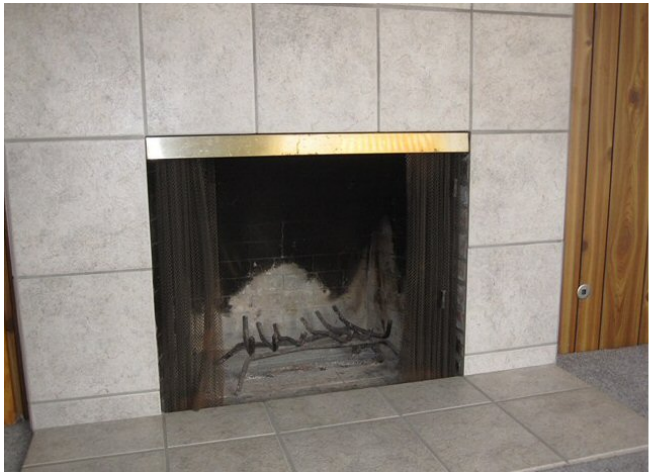
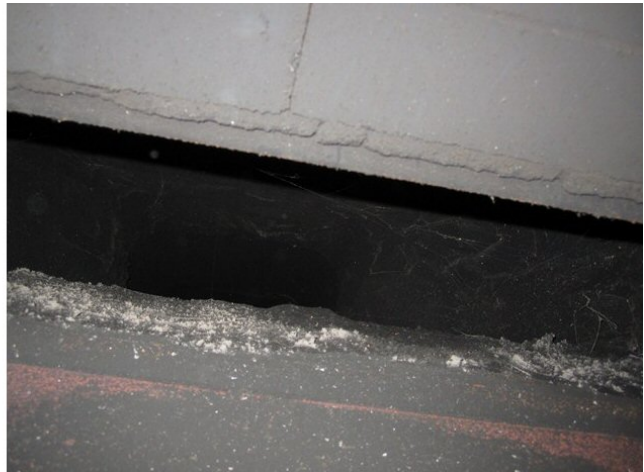
Fireplace

Comments: The fireplace, hearth and facing were found to be in serviceable condition. The firebox was also found to be in serviceable condition with no significant cracking. The damper was operated and found to be functional. Soot fell from the flue when the damper was opened. A partial inspection of the entrance to the chimney flue was attempted from the firebox using a mirror and a flashlight; the type of flue opening prevented a proper inspection of the flue, and no opinion is offered as to the condition of the flue interior. These areas would benefit from cleaning.

Recommendations: clean the fireplace flue. Note: no opinion is offered as to the actual condition of the flue since it was not thoroughly inspected.

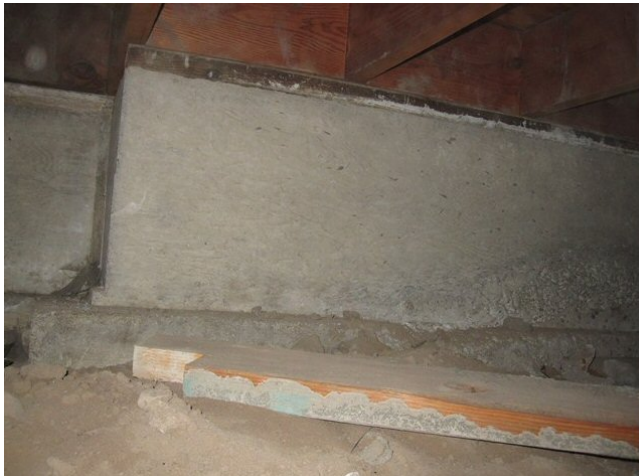
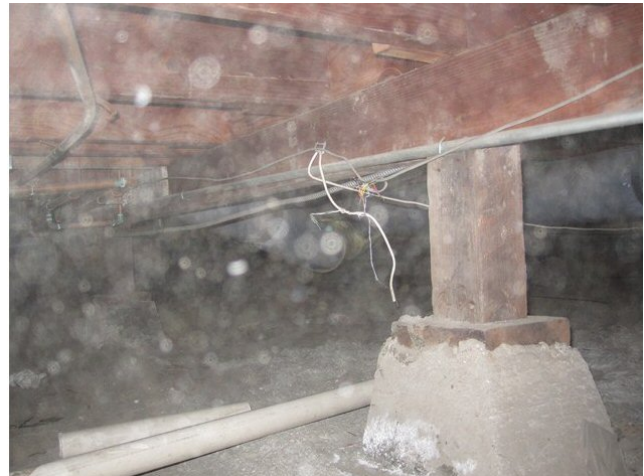
Foundation

Comments: The overall condition of the foundation was assessed from the crawlspace. No signs of severe or unusual cracking were noted at the base of cripple walls in the areas where they were visible. The subfloor crossbeams are supported by timber columns which stand on concrete foundation piles. Subfloors and supports were found to be in serviceable condition. Sills are anchor bolted with the bolts visible in several places (for example below right).

Recommendations: None.

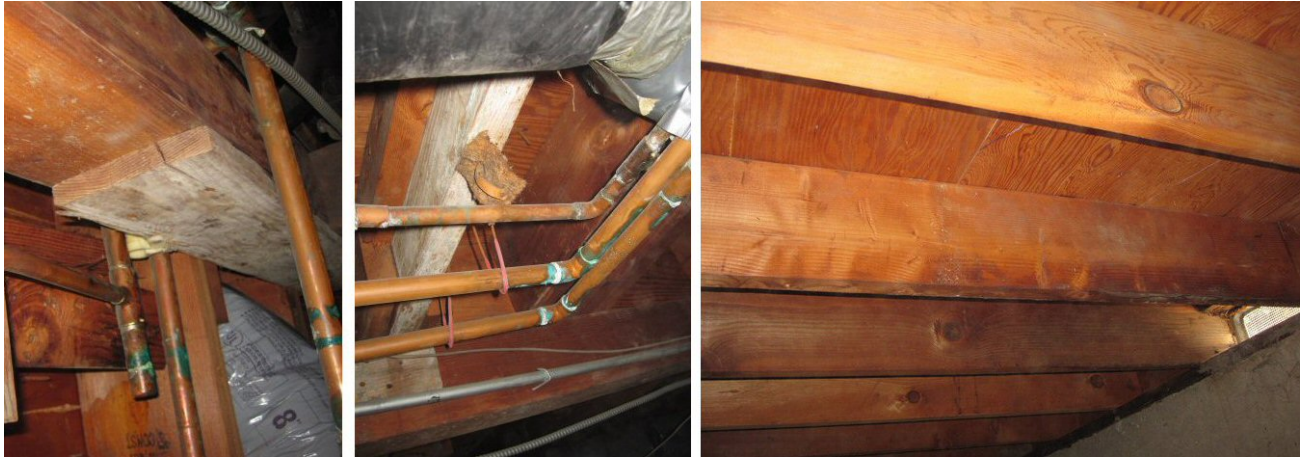
Crawl Space

Comments: Clearance in this area is restricted to less than twelve inches in areas below plumbing and/or heating ducts. The crawl space was found to be dry. There were signs of a previous leak in the plumbing below the hallway bathroom - timbers were damaged in this area. This area was dry at the time of the inspection.

Recommendations: consult a specialist inspector with regard to damage to structural timbers in the crawlspace.

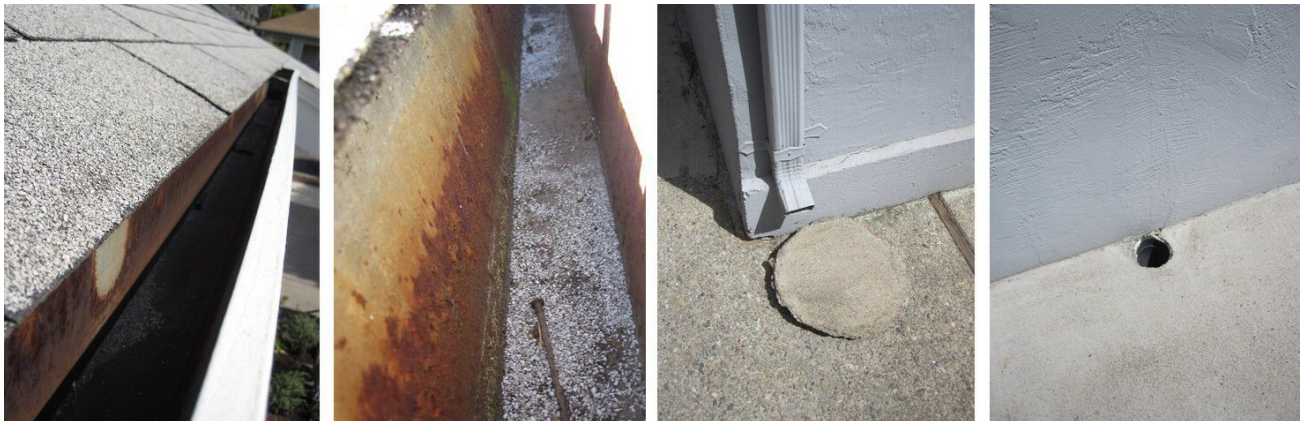
Comments: The building has full gutters and downspouts that were noted to be in overall poor to adequate condition. The gutters were inspected from the eaves and were found to be heavily rusted. Some of the gutters were blocked. Downspouts were fitted with extensions and/or splash blocks. Several drainage openings exist at locations no longer served by downspouts.

Recommendations: replace the roof drainage system when the roof is replaced.

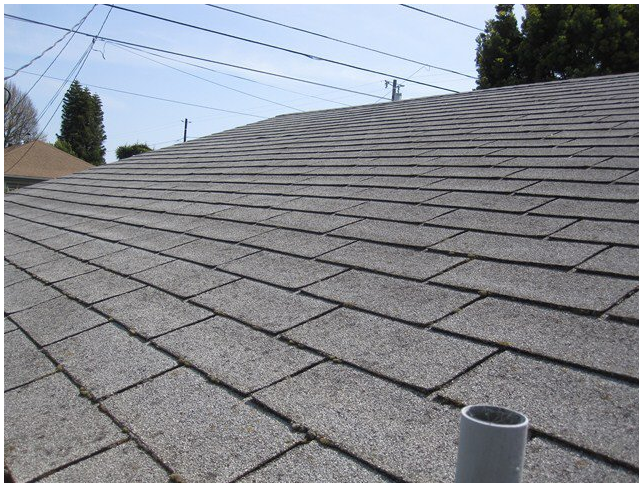
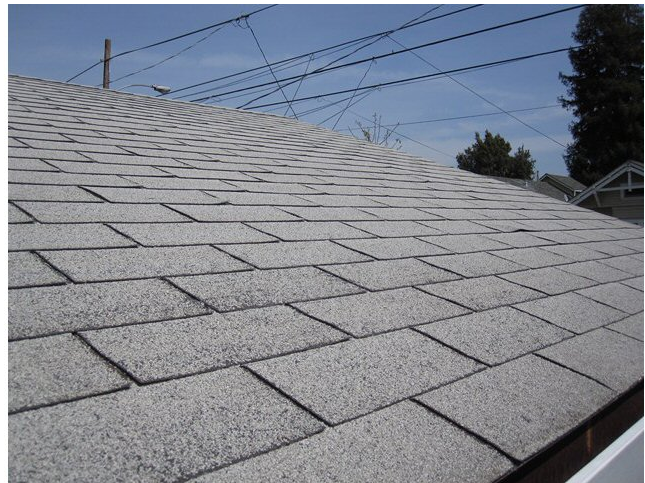
Comments: The roof is in poor condition and requires replacement. Since most of the damage caused to roofing shingles comes from the sun, shingles are covered with quartz granules to deflect sunlight & heat. The first indications that shingles are deteriorating is the loss of some of these particles, which erode naturally with time as they become dried out. Eventually, sunlight heats the exposed shingles to the point where they begin to curl up and crack. Quartz particles were mostly eroded on the roof.

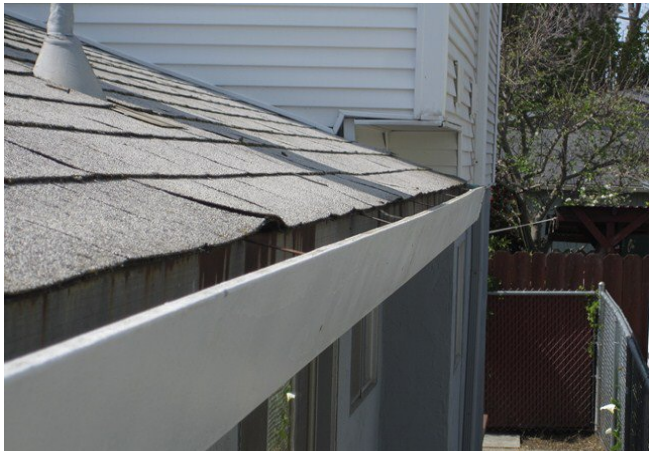
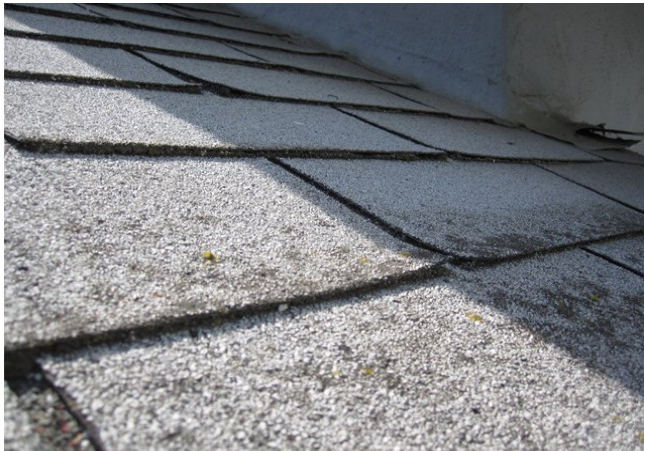
Curled shingles were present throughout the roof and at the edges of the roof. The right side of the roof at the rear was covered with moss. Flashings at roof vents are rusted, and have been repaired with roofing cement a number of times.

Recommendations: The roof covering requires replacement.

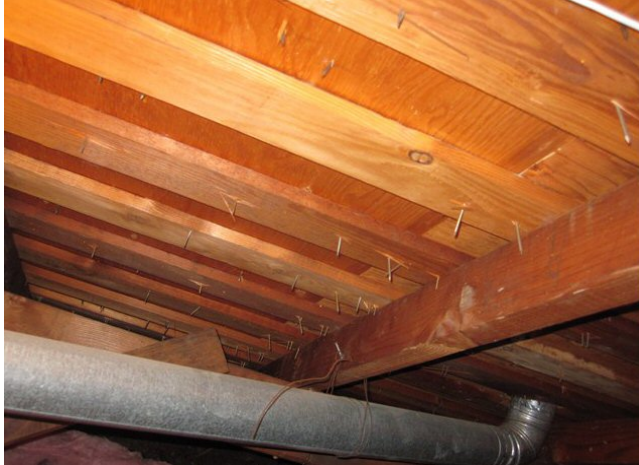
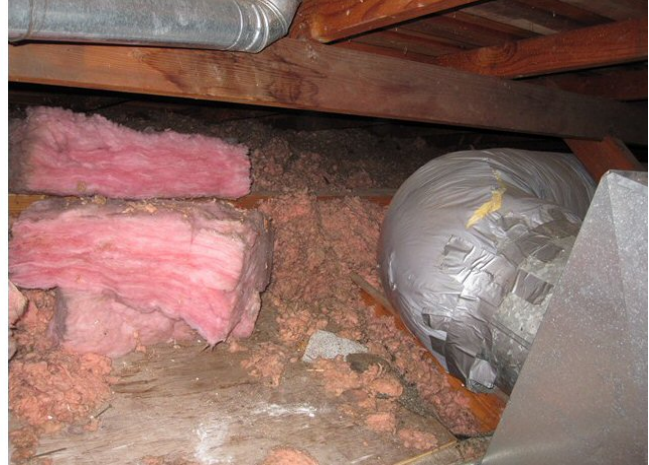
Attic

Comments: Rafters, other framing members and roof sheathing were noted to be in serviceable condition. There were no signs of water staining in visible areas of the under-side of the roof. The attic floor has been insulated with several inches of fiberglass-type material.

Recommendations: None.

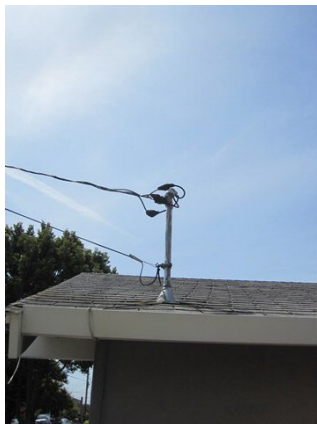
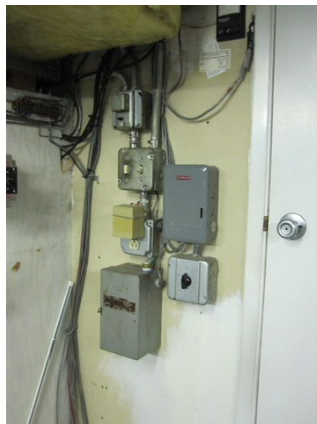
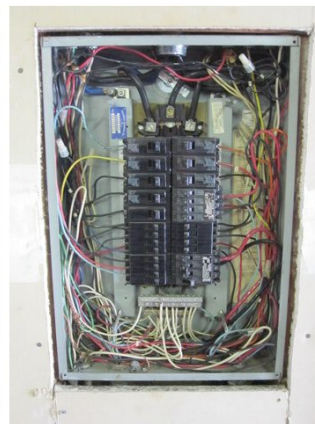
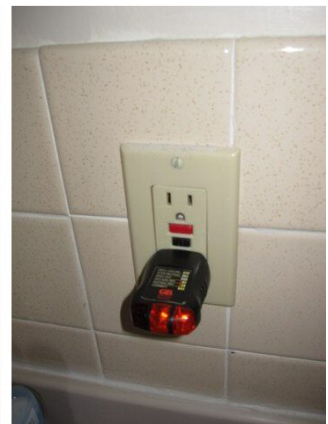
Comments: The overall condition of the accessible fixtures, switches and outlets was noted to be serviceable. All accessible electrical outlets were tested for open hot wires, open neutrals, correct polarity and, open grounds. No defects were found. Ground Fault Circuit Interrupter (GFCI) type device(s) were present in bathroom(s). Exactly which device protects which outlets was not established.

Recommendations: None.

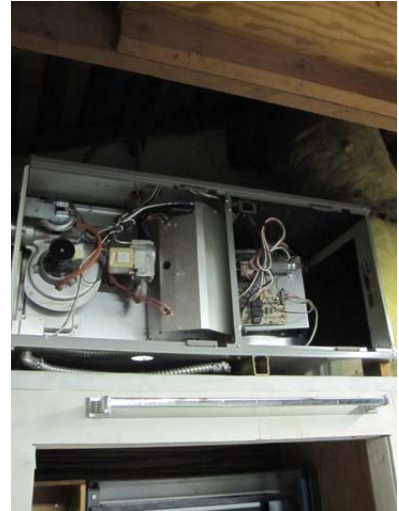
Comments: The furnace area is adequately vented. Flue pipe connections appear proper as readily visible above the furnace. The furnace was found to be in good condition. Gas supply to the furnace was turned on at the time of the inspection. The furnace was operated by raising the desired temperature at the thermostat. The furnace responded within a few minutes, and circulated warm air to registers. Access to the heat exchange areas is so limited that no assessment of the condition of the heat exchanger(s) can be made. The furnace gas supply line and gas shut-off valve appear to be in serviceable condition.

Recommendations: It is considered good practice to have the furnace inspected annually by a qualified engineer or gas safety specialist familiar with this type of appliance. The filter should be changed after transfer of the property and at least every twelve months thereafter; some furnace manufacturers recommend more frequent filter changes.

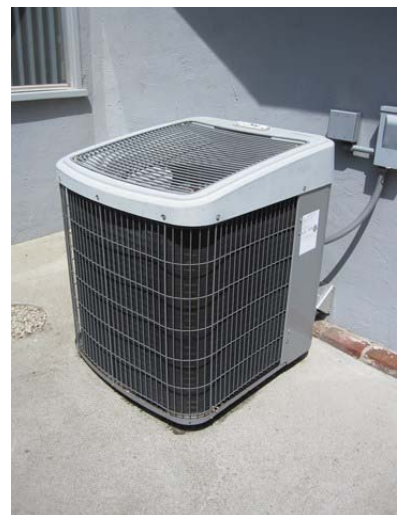
Air Conditioning

Comments: The air conditioning was operated by lowering the desired temperature at the thermostat. Cool air was circulated within a few minutes to all registers. The evaporator coils are located along the left side of the building towards the front, and were found to be in serviceable condition.

Recommendations: None.

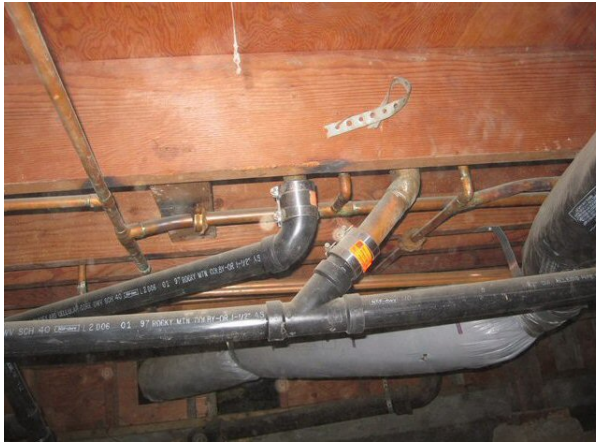
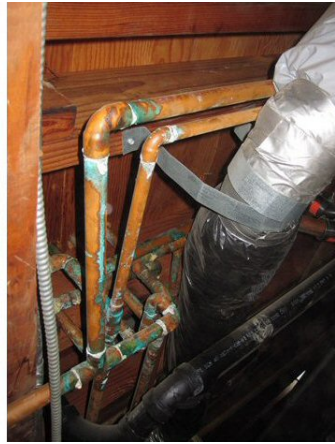
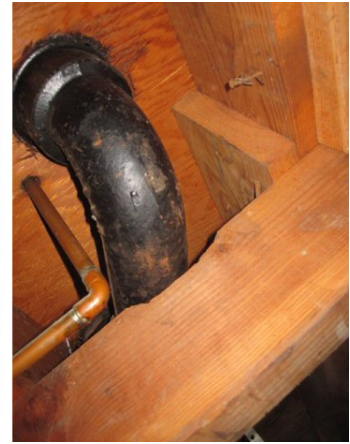
Comments: Pipes were examined where visible, which was restricted to portions below sinks inside the house and in the crawl space. Some evidence of corroded pipe work was noted below the hallway bathroom.

Recommendations: None.

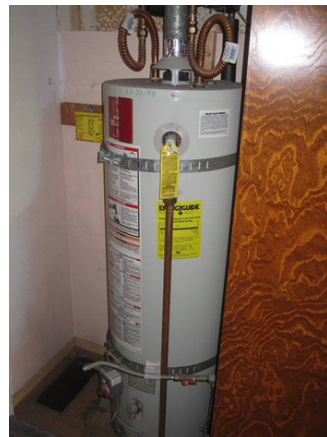
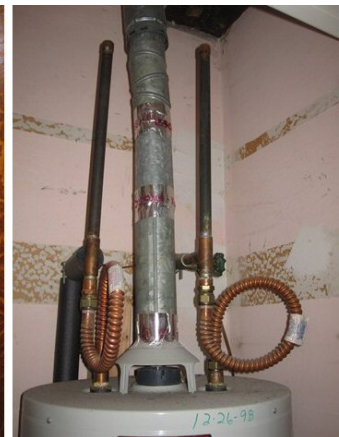
Water Heater

Comments: The water heater appears to be in serviceable condition. The water heater is secured with two seismic restraining straps. Natural gas connection and shut off valve were found to be in serviceable condition. Pipe connections and flue pipes appear to be correctly installed. The heater is equipped with a temperature/pressure (T/P) relief valve. This is an important safety device and should not be tampered with. The T/P relief valve appears to be properly installed. Piping from the valve is routed to the exterior. The exit pipe is an important safety feature, which should not be moved or blocked off.

Recommendations: None.

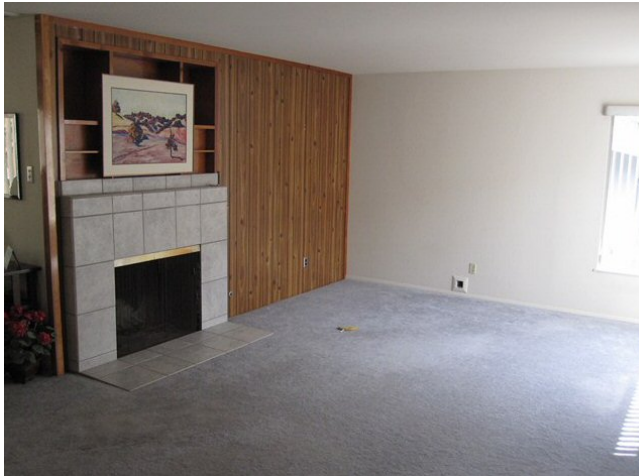
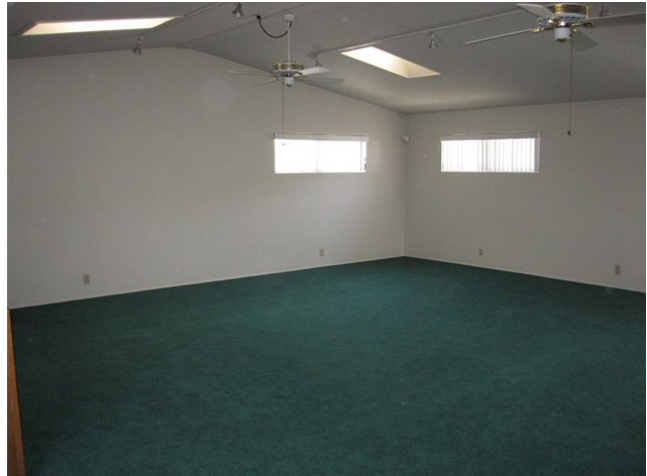
Comments: The living and dining areas were found to be in generally serviceable condition. The overall condition of the interior doors was noted to be serviceable. Ceilings were noted to be in generally serviceable condition. There was some damage to the ceiling in the recreation room. Walls were generally in serviceable condition with few examples of cosmetic damage - chips, marks, minor holes, small cracks etc. Floor coverings were found to be in serviceable condition throughout. No evidence of sloping floors was noted; floor coverings prevented a full inspection of floors. Ceiling fans in the recreation room were fully operable.

Recommendations: None.

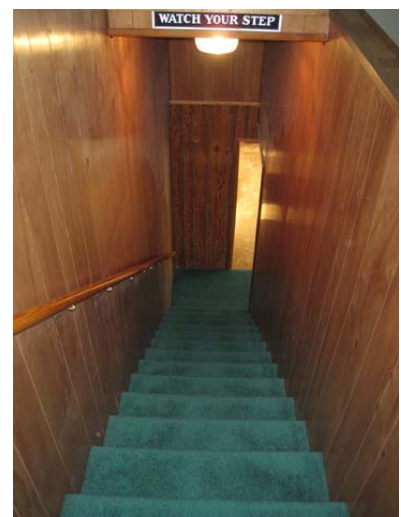
Stairs & Handrails

Comments: The overall condition of these areas was noted to be serviceable. Carpeting on the stairs was had been correctly fitted and was in serviceable condition. Banisters and handrails were securely fastened.

Recommendations: None.

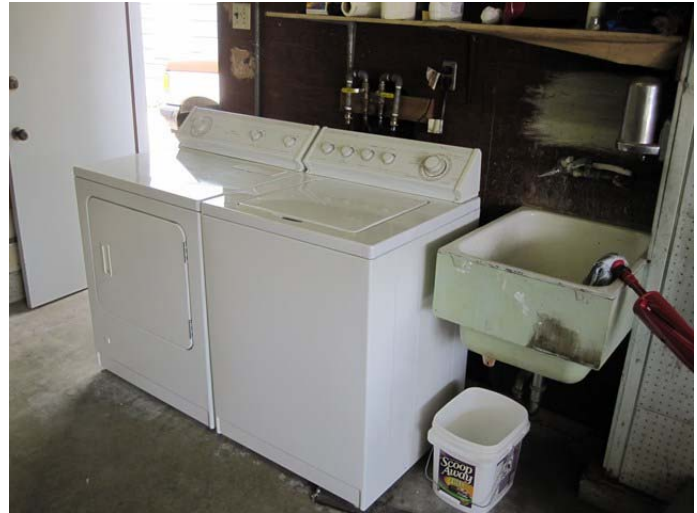
Laundry

Comments: The laundry area was found to be in serviceable condition. Plumbing and drain connections were available for connection of the washing machine. The dedicated sink was found to be in serviceable condition. There is a natural gas connection present in this area for connection of a natural gas powered clothes dryer. The dryer air vent is routed to the exterior via the right side garage wall. The dryer vent cover was missing.

Recommendations: install a cover at the exterior of the clothes dryer air vent.

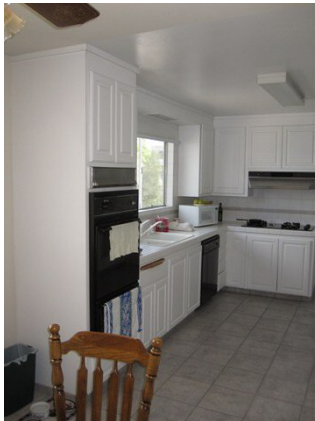
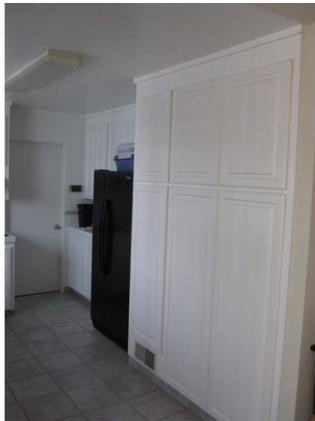
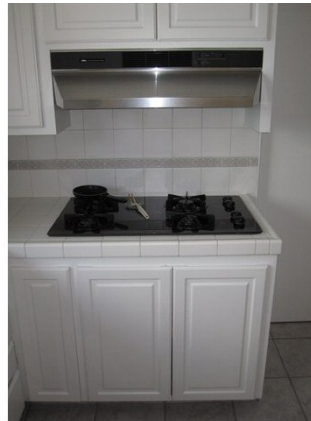
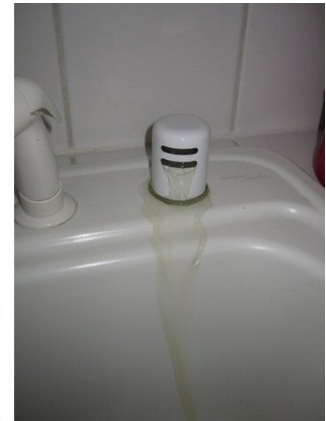
Comments: The kitchen was found to be in overall serviceable condition. Ceilings were noted to be in serviceable condition with no signs of leaks, water stains or serious marks. Walls were generally in serviceable condition, with few examples of cosmetic damage - chips, marks, minor holes, small cracks etc. The tile floor covering was in serviceable condition with no serious marks or cracks. The overall condition of the countertops and cabinets was noted to be serviceable. Drawers and cabinet doors were all fully operable.

The sink unit was found to be in serviceable condition with no signs of leaks around the sink or in the cabinet below. Plumbing fixtures were fully operable. The waste disposal unit was operated and found to run quietly. The dishwasher drains through the air gap at the sink. The stove top front right burner was not operable. The gas oven and broiler were working. The oven light was operable. The exhaust extractor unit was operated and found to run quietly with a choice of speeds. The light inside the hood was functional. No fire extinguisher was present in the kitchen.

Recommendations: clear the blockage in the plumbing in order for the dishwasher to drain correctly. repair the front right gas burner at the stove top. It is advisable to keep a multi-purpose fire extinguisher in the kitchen at all times in case of fire. A high percentage of household fires start in kitchen areas.

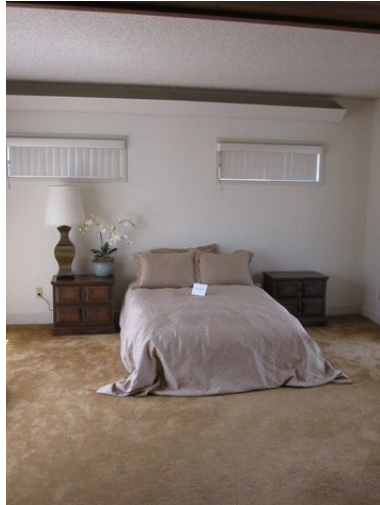
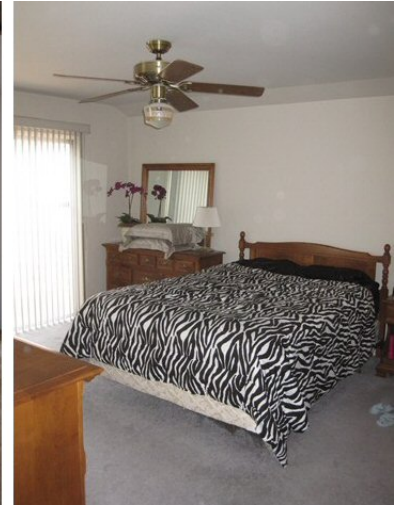
Bedrooms

Comments: The overall condition of the bedrooms was noted to be serviceable. Ceilings were noted to be in serviceable condition with no signs of leaks, water stains or serious marks. Walls were generally in serviceable condition, with few examples of cosmetic damage - chips, marks, minor holes, small cracks etc. Floor coverings were found to be in serviceable condition throughout. No evidence of sloping floors was noted; floor coverings prevented a full inspection of floors. Ceiling fans in the bedrooms were fully operable.

Recommendations: None.

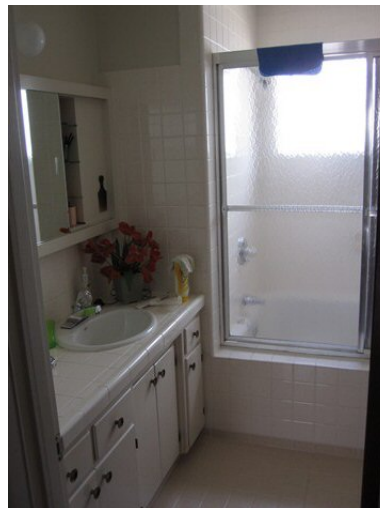
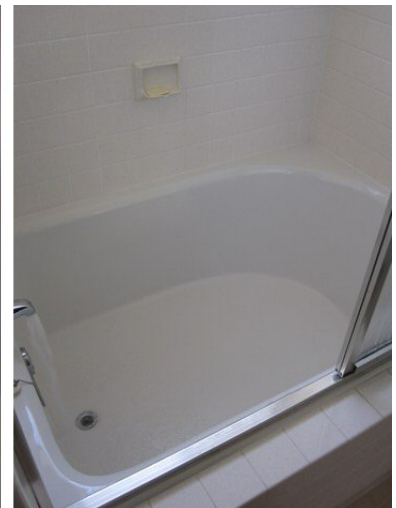
Bathroom One

Comments: The bathroom was found to be in generally serviceable condition. Water supply was connected to all fixtures in this bathroom. The shower unit was operated and found not to leak at the shower head or at the sliding glass doors. (Note: these doors will leak if sprayed with water for a prolonged period). The sink was tested and found not to leak in under-sink areas. The tub was tested and found not to leak. The toilet was securely fitted to the floor and refilled properly after being flushed. The exhaust fan is operated independently of the bathroom lights, and ran quietly.

Recommendations: None.

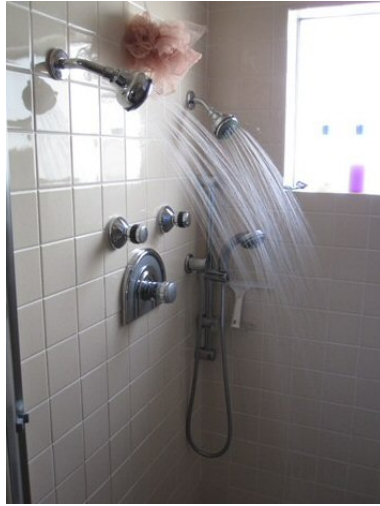
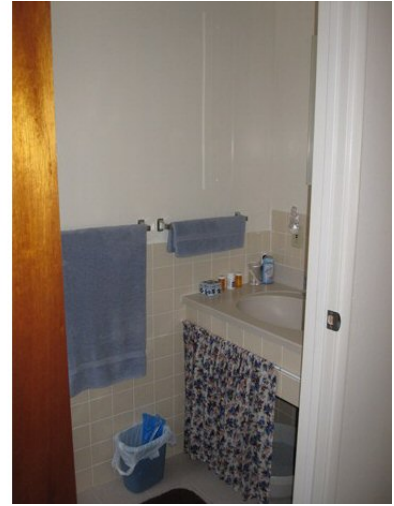
Bathroom Two

Comments: The bathroom was found to be in generally serviceable condition. Water supply was connected to all fixtures in this bathroom. The shower unit was operated and found not to leak at the multiple shower heads or at the sliding glass doors. (Note: these doors will leak if sprayed with water for a prolonged period). The sink was tested and found not to leak in under-sink areas. The tub was tested and found not to leak. The toilet was loose at the floor and requires refitting. The exhaust fan is operated independently of the bathroom lights, and ran quietly.

Recommendations: reseal the toilet at the floor and bolt in place.

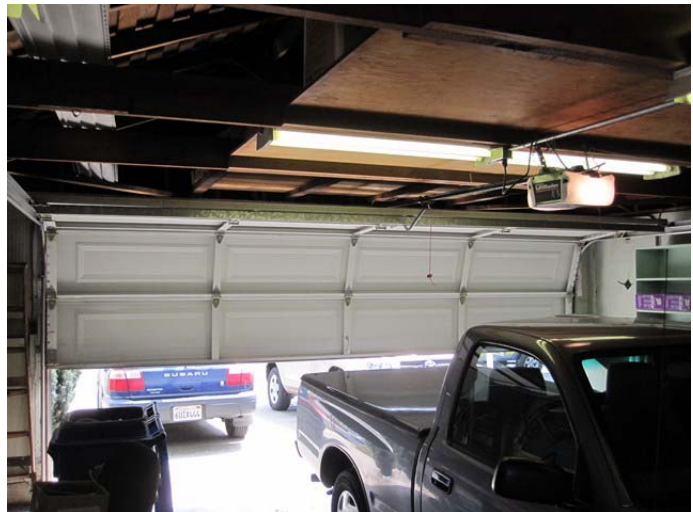
Comments: The vehicle door was found to be in serviceable condition. There is an automatic garage door opener present which is connected directly to a dedicated outlet. The automatic reverse safety mechanism was not tested, since testing can cause damage to the vehicle door in the event that the mechanism is non-functional.

Recommendations: None.
